# Manhole Inspection Summary

Manhole # S09CC2006MH

**Location** Address: **5858 PIMILICO RD** Cross Street: **ROCKWOOD AVE**

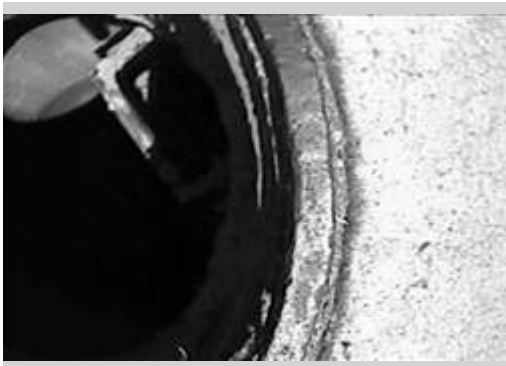
Frame offset

**Frame** Offset: **1** (in.) Condition: ☒ Sound ☐ Cracked ☐ Leaks

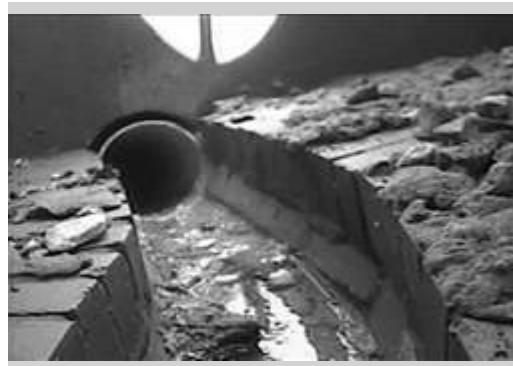
Defect

**Bench** ☒ Exists Material: **Brick** ☐ Parged ☒ **Debris** (not Condition related)  
Condition: ☐ Sound ☐ Cracked ☐ Root Intrusion ☐ Deteriorated ☐ Leaks ☒ **Debris**

**Channel** Material: **Brick** ☐ Parged ☒ **Debris** (not Condition related)  
Channel Exposure: **Fully Open** Junc Dist: **0** nearest .5 ft. Azimuth:  
Condition: ☐ Sound ☐ Cracked ☐ Root Intrusion ☐ Deteriorated ☐ Leaks ☒ **Debris**

Bench and Channel debris.

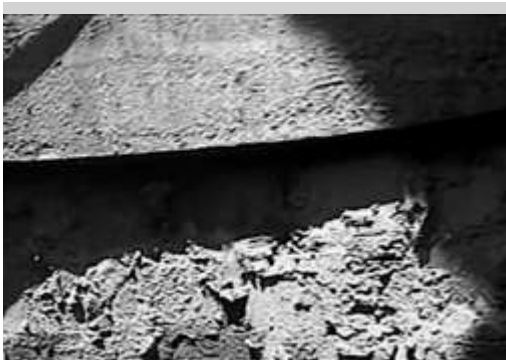
Defect

**Chimney / Frame Adjustment** ☒ Exists Material: **Brick** ☐ Parged Height: **10** (in.)  
Condition: ☒ Sound ☐ Cracked ☐ Root Intrusion ☐ Loose Brick ☐ Deteriorated  
Infiltration: ☐ None ☒ **Joint** ☐ Cracks ☒ **Mortar** ☐ Roots ☐ Wall

Adjustment infiltration and deterioration.

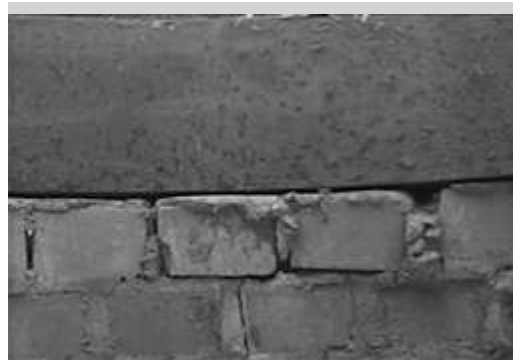
Defect

Adjustment infiltration.

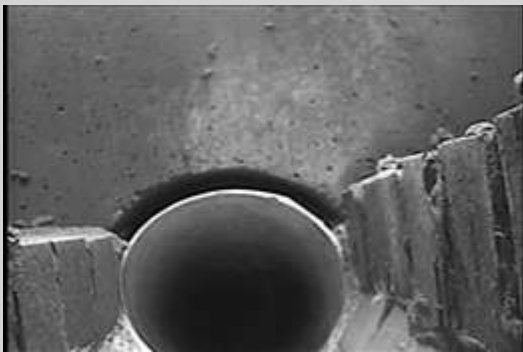
### 8 in. Circular Gravity Sewer Pipe Out @ 12 O'Clock

Pipe Material: **PVC** ☐ Pipe Lined

Invert Depth: **9.31** (ft.) Flow Characteristics: **None**

Deposits: ☒ None ☐ Mud ☐ Sludge ☐ Debris ☐ Grease

Infiltration: **None** Pipe Seal Cond: **Unknown**

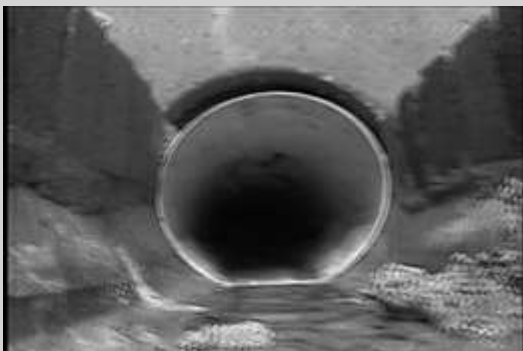
### 8 in. Circular Gravity Sewer Pipe In @ 6 O'Clock

Pipe Material: **PVC** ☐ Pipe Lined

Invert Depth: **8.20** (ft.) Flow Characteristics: **None**

Deposits: ☒ None ☐ Mud ☐ Sludge ☐ Debris ☐ Grease

Infiltration: **None** Pipe Seal Cond: **Unknown**
